**Flood Control Project Maintenance
Levee Inspections**
LMA District Cover Sheet
Spring 2017 Levee Inspection Results

Reclamation District No. 0544 Upper Roberts Island

Spring 2017 Levee Inspection Results

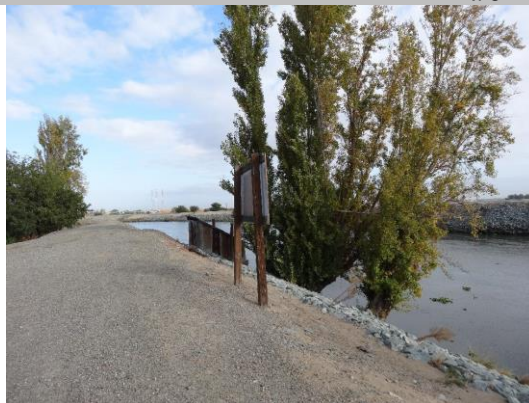
Photo 1 of 3 : UCIP_SP_2017_41906_41713.jpg

LM Start	0.01	Rating **	M	Issue No.	127
LM End	0.01	Issue Type +	En	Location *	N/A
Category	Supplemental			GPS Latitude/Longitude	
				Start	End
Item	DWR UCIP Field Study			37.870356 °	37.870356 °
				-121.329852 °	-121.329852 °
DWR ID					
Comment Code					
Inspector Comment					
FS_ID:41906					
DS_ID:22640					
EP_NO: 4116					
Repair Type: Non-Urgent					
Crossing Status: Found					
UCIP Comments: Need to contact owner to determine status.- a signboard on waterside shoulder and across the river.- no indicators on landside.					
FIELD_STRUCT_DESC: 8-5/8-inch steel gas line through the levee, 3.9 feet below the crown and under the river channel. Waterward slope rock revetted. (App. No. 4116 - PG&E) O&M Manual SJR 007, April 1964.					
FS Date: 10/29/2013

WS view: a signboard indicating a gasoline on levee shoulder.

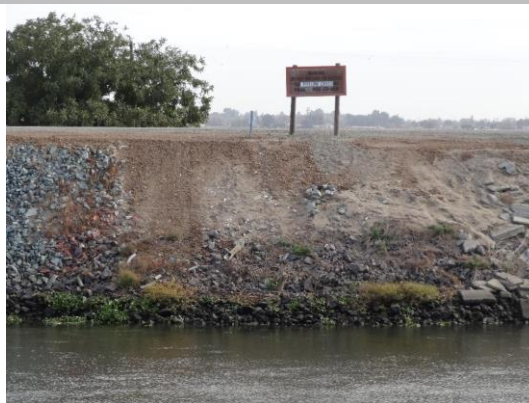
Photo 2 of 3 : UCIP_SP_2017_41906_41712.jpg

WS view: a signboard indicating a gasoline across the river channel.

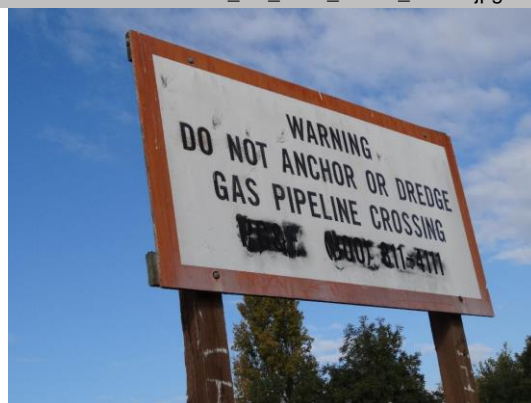
Photo 3 of 3 : UCIP_SP_2017_41906_41711.jpg

WS view: closer view of a signboard indicating a gasoline on levee shoulder.

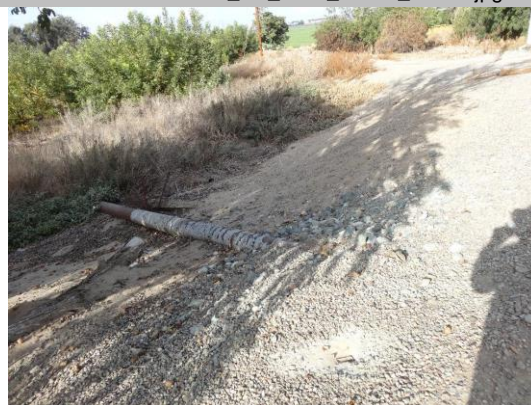
Photo 1 of 3 : UCIP_SP_2017_23851_41728.jpg

LM Start	0.01	Rating **	M	Issue No.	128
LM End	0.01	Issue Type +	En	Location *	N/A
Category	Supplemental			GPS Latitude/Longitude	
				Start	End
Item	DWR UCIP Field Study			37.870296 °	37.870296 °
				-121.329826 °	-121.329826 °
DWR ID					
Comment Code					
Inspector Comment					
FS_ID:23851 DS_ID:24713 EP_NO: N/A Repair Type: Non-Urgent Crossing Status: Found UCIP Comments: Appears abandoned.May need proper abandonment.Pipe exposed on landside slope. FIELD_STRUCT_DESC: *ABANDONED* A 12-inch steel pipe through the levee, 2 feet below levee crown. Appears abandoned. Only visible on landside slope. No pipe and other features visible on waterside. FS Date: 10/29/2013

LS view: exposed 12-inch steel pipe on levee slope. Appears abandoned.

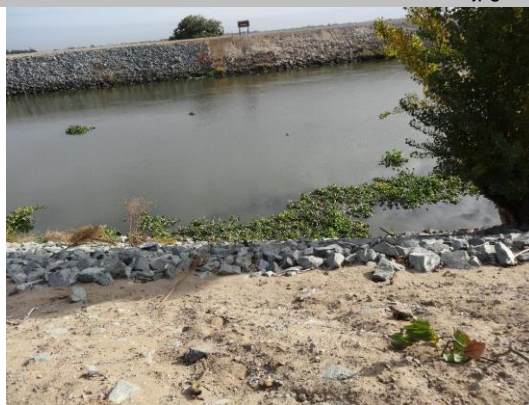
Photo 3 of 3 : UCIP_SP_2017_23851_41726.jpg

WS view: no pipe and appurtenances found on waterside.

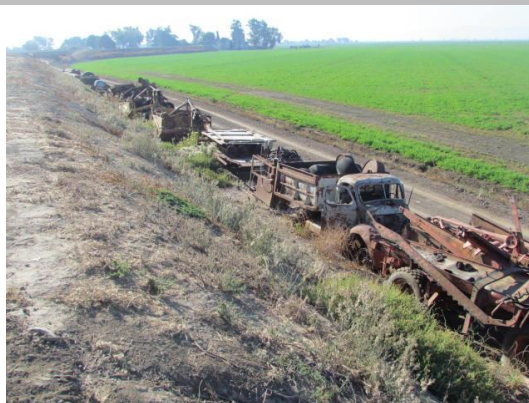
Photo 2 of 5 : SP_2017_RD0544_108_4_20170316_00005.jpg

Looking southwest at equipment stored at landward toe fall 2015.

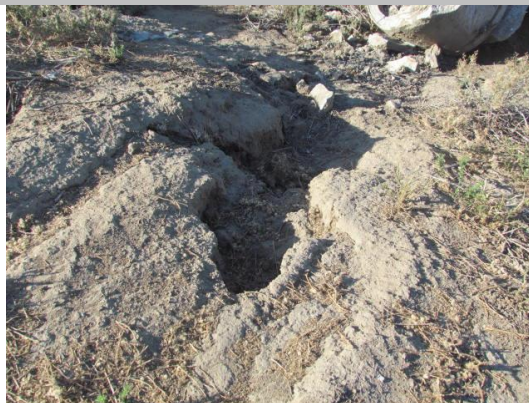
Photo 1 of 1 : SP_2017_RD0544_108_118_20170316_00075.jpg

LM Start	0.06	Rating **	U	Issue No.	118
LM End	0.06	Issue Type +	Ma	Location *	LS
Category	Earthen Levee			GPS Latitude/Longitude	
				Start	End
Item	Erosion / Bank Caving			37.869570 °	37.869570 °
				-121.329556 °	-121.329556 °
DWR ID	DWR_RD0544_01_f_2015_118				
Comment Code					
E2 : Schedule repair of erosion site prior to the next inspection.					
Inspector Comment					
Finger erosion noted on landward slope.

Looking west at landside erosion for shoulder to middle of levee slope.

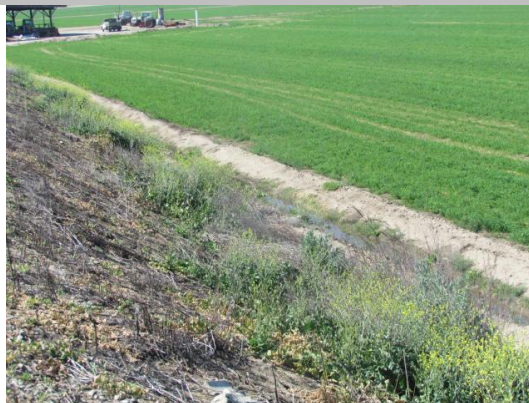
Photo 1 of 1 : SP_2017_RD0544_108_85_20170316_00054.jpg

Looking southwest at Irrigation ditch at landward toe.

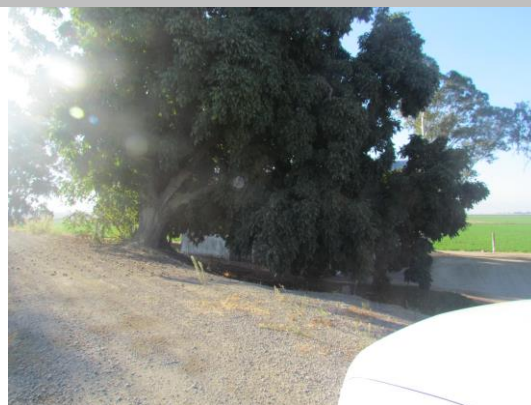
Photo 1 of 1 : SP_2017_RD0544_108_2_20170316_00002.jpg

Looking southwest at untrimmed tree on landward slope.

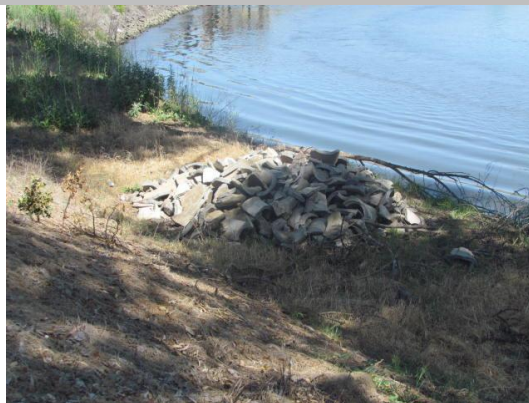
Photo 1 of 1 : SP_2017_RD0544_108_1_20170316_00001.jpg

LM Start	0.45	Rating **	M	Issue No.	1
LM End	0.45	Issue Type +	En	Location *	WS
Category	Earthen Levee			GPS Latitude/Longitude	
				Start	End
Item	Encroachments			37.864713 °	37.864713 °
				-121.326708 °	-121.326708 °
DWR ID	DWR_RD0544_01_f_2013_1				
Comment Code					
MA : Material					
Inspector Comment					
Old broken concrete pipes on waterward berm.

Looking northeast at broken concrete piping on waterward berm.

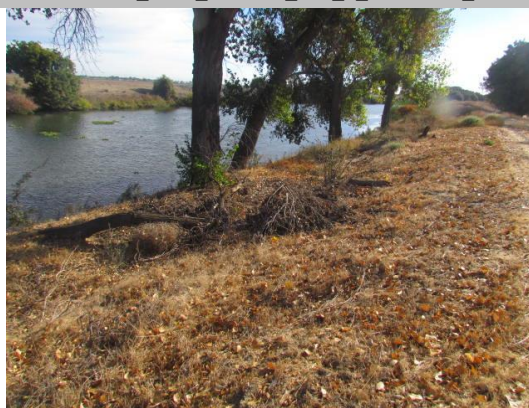
Photo 1 of 1 : SP_2017_RD0544_108_6_20170316_00009.jpg

LM Start	0.45	Rating **	M	Issue No.	6
LM End	0.45	Issue Type +	Ma	Location *	WS
Category	Earthen Levee			GPS Latitude/Longitude	
				Start	End
Item	Encroachments			37.864713 °	37.864713 °
				-121.326708 °	-121.326708 °
DWR ID	DWR_RD0544_01_f_2013_6				
Comment Code					
PR : Prunings					
Inspector Comment					
Broken tree limbs on waterward slope and berm.

Looking southeast at tree branch on waterward slope.

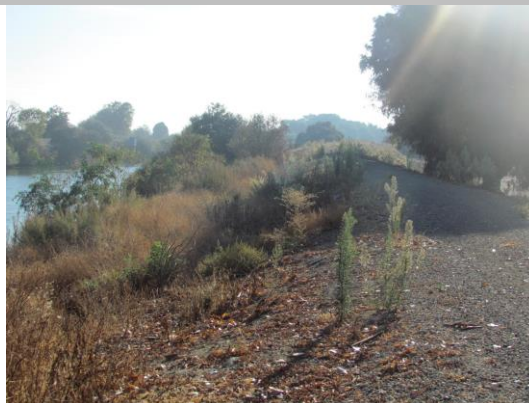
Photo 1 of 1 : SP_2017_RD0544_108_3_20170316_00003.jpg

LM Start	0.48	Rating **	U	Issue No.	3
LM End	0.67	Issue Type +	Ma	Location *	WS
Category	Earthen Levee			GPS Latitude/Longitude	
				Start	End
Item	Vegetation			37.864578 °	37.863753 °
				-121.326210 °	-121.322835 °
DWR ID	DWR_RD0544_01_s_2012_3				
Comment Code					
V2 : Remove the wild growth other than native grasses from the levee slopes.					
Inspector Comment					
Dense vegetation on waterward and landward slopes.

Looking south at dense veg on waterward slope.

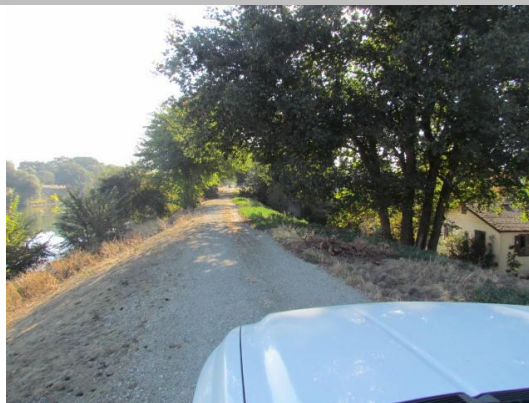
Photo 1 of 2 : SP_2017_RD0544_108_9_20170316_00010.jpg

Looking southwest at dense landscaping on landward slope fall 2015

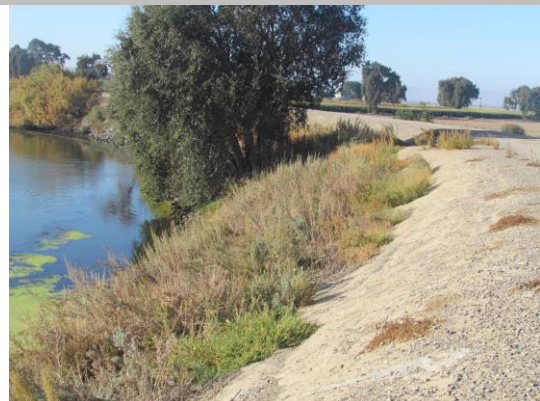
Photo 1 of 1 : SP_2017_RD0544_108_19_20170316_00017.jpg

Looking south at typical of dense veg on waterward slope.

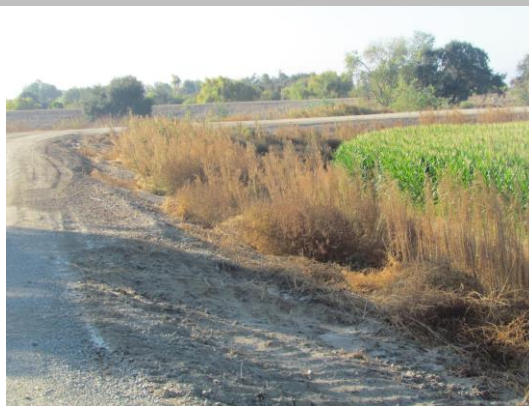
Photo 1 of 1 : SP_2017_RD0544_108_42_20170316_00032.jpg

Looking at dense veg. on landward slope and toe.

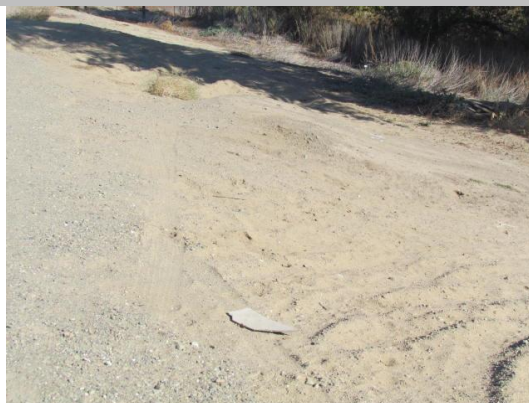
Photo 3 of 3 : SP_2017_RD0544_108_119_20170316_00078.jpg

Looking southeast at damaged waterward slope fall 2015

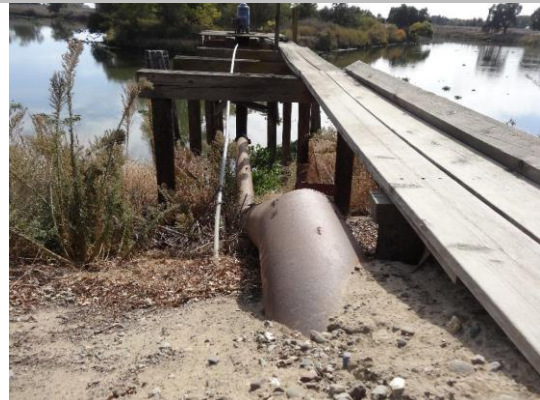
Photo 1 of 3 : UCIP_SP_2017_51351_41786.jpg

Comment Code					
Inspector Comment					
FS_ID:51351 DS_ID:22648 EP_NO: 4114 Repair Type: Non-Urgent Crossing Status: Found UCIP Comments: 12/22/2016: No signs of erosion or depressions found on either levee slope. Slope may have been backfilled but cause of original depression (likely a pipe integrity problem) may not have been addressed. Walkway still in poor structural condition. Downgraded this crossing from Urgent to Non-Urgent. (K. Fazel - UCIP)10/29/2013:- levee depression on both sides of the levee.- 2-inch electric conduit on waterside and service pole on landside.Walkway in poor structural condition. (P. Amatya - DWR) FIELD_STRUCT_DESC: 18-inch steel irrigation pipe through the levee, 2 feet below the crown. Pump mounted on a pile structure pier in the stream. Siphon breaker on the apex of the pipe on the landside (LS) slope. Concrete standpipe at the LS toe. 2-inch electric conduit through the levee and service pole on the LS toe. (Permit No. 4114, 1962 - Feck) [Additional Reference(s): USACE San Joaquin O&M Manual 007, April 1964 (HLM 1.75). DWR Levee Log, 2005]. Note: Levee Log cites a 14-inch, Permit No. 4114 cites a 20-inch, O&M Manual cites a 14-inch, 20 feet below the crown. FS Date: 12/22/2016

WS view: pipe, conduit, walkway, and pump on levee slope.

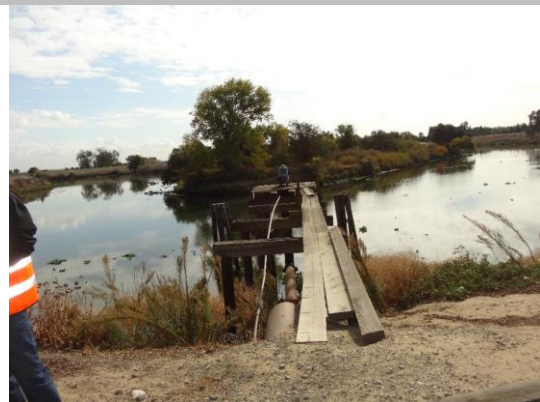
Photo 3 of 3 : UCIP_SP_2017_51351_41784.jpg

WS view: depression on levee shoulder near walkway. Half of the walkway stripped off.

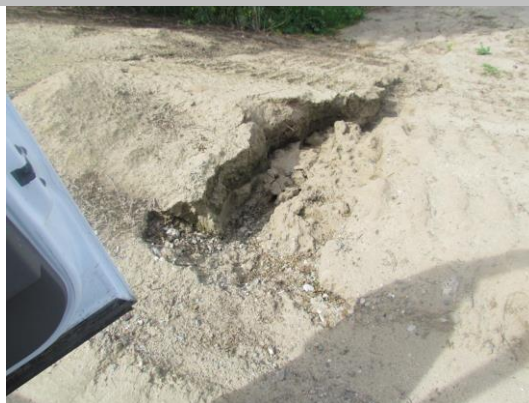
Photo 1 of 2 : SP_2017_RD0544_108_80_20170407_00129.jpg

LM Start	1.82	Rating **	U	Issue No.	80
LM End	1.82	Issue Type +	Ma	Location *	LS
Category	Earthen Levee			GPS Latitude/Longitude	
				Start	End
Item	Erosion / Bank Caving			37.853173 °	37.853173 °
				-121.324145 °	-121.324145 °
DWR ID	DWR_RD0544_01_s_2017_80				
Comment Code					
E2 : Schedule repair of erosion site prior to the next inspection.					
Inspector Comment					
Repair slope damage due to water runoff.

Looking west at slope damage due to rain runoff on waterward slope.

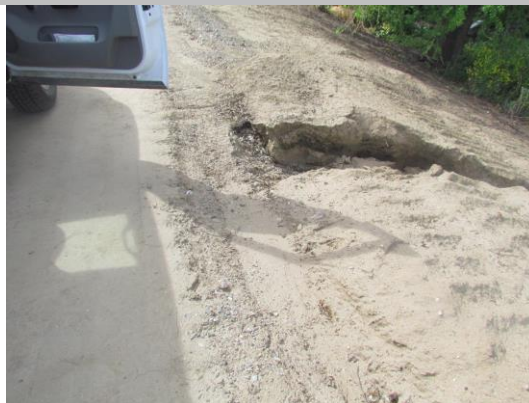
Photo 2 of 2 : SP_2017_RD0544_108_80_20170407_00130.jpg

Looking south at slope damage due to rain runoff on waterward slope.

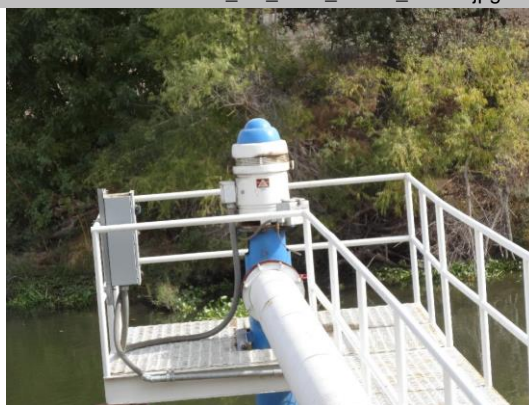
Photo 2 of 3 : UCIP_SP_2017_51352_42006.jpg

WS view: steel pipe, walkway to the pump, and pump on steel pile structure in the stream.

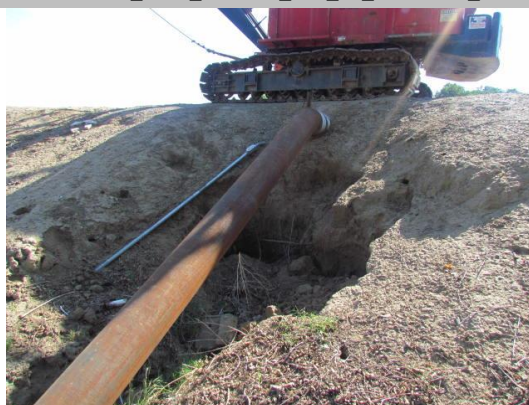
Photo 3 of 3 : SP_2017_RD0544_108_23_20170316_00020.jpg

LM Start	2.26	Rating **	U	Issue No.	23 (cont)	
LM End	2.26	Issue Type +	Ma	Location *	LS	
Category	Earthen Levee			GPS Latitude/Longitude		
				Start		End
Item	Erosion / Bank Caving			37.848155 °		37.848155 °
				-121.324897 °		-121.324897 °
DWR ID	DWR_RD0544_01_s_2012_23					
Comment Code						
E2 : Schedule repair of erosion site prior to the next inspection.						
Inspector Comment						
Caving/erosion around irrigation pipe on landside slope.

Looking east at erosion under irrigation pipe on landside slope.

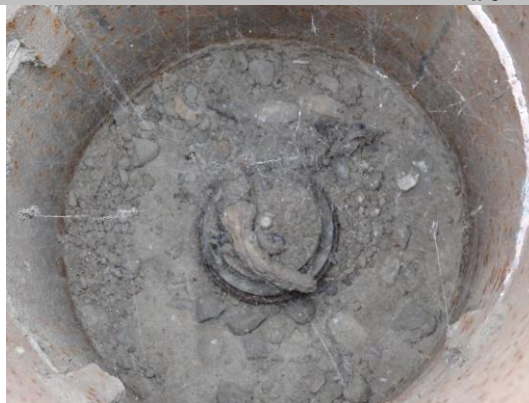
Photo 3 of 3 : UCIP_SP_2017_51349_44828.jpg

FS_ID:51349
DS_ID:22652
EP_NO: 13554
Repair Type: Urgent
Crossing Status: Found
UCIP Comments: 12/22/2016:Depression (hole) in levee in two places on the WS slope in alignment with this pipe. One of the holes is due to rodent activity. Crossing has been upgraded from Non-Urgent to Urgent. (K. Fazel - UCIP)10/29/2013:- levee slope erosion on landside.- needs cleaning of siphon breaker. (P. Amatya - DWR)
FIELD_STRUCT_DESC: 12-inch steel discharge pipe, 2 feet below the crown. Pump in concrete standpipe on drainage ditch on the landside (LS) toe. Siphon breaker in steel riser on the waterside (WS). (Permit No. 13554, 1982 - Phelps). [Additional Reference(s): DWR Levee Log, 2005].
FS Date: 12/22/2016

WS view: siphon breaker inside steel pipe riser on levee slope. Needs dirt cleaning/clearing.

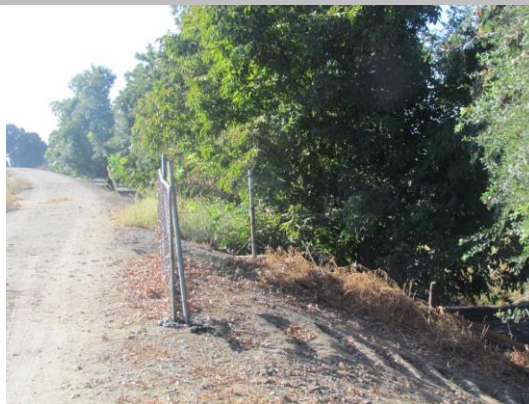
Photo 1 of 1 : SP_2017_RD0544_108_98_20170316_00063.jpg

Looking south at untrimmed trees on landward slope.

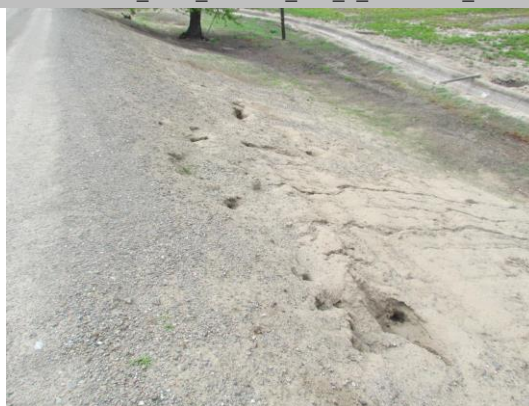
Photo 1 of 1 : SP_2017_RD0544_108_8_20170407_00132.jpg

Looking southwest at several rodent holes on landward shoulder and slope.

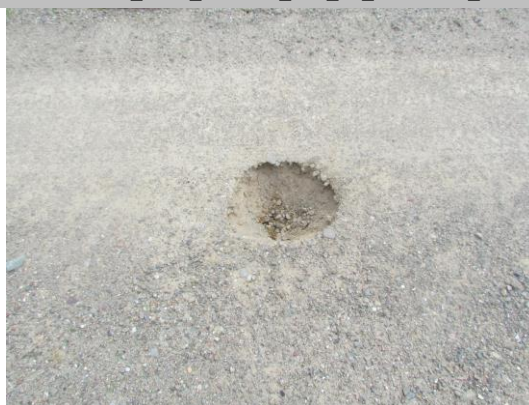
Photo 1 of 1 : SP_2017_RD0544_108_90_20170410_00133.jpg

Looking at sinkhole on levee crown.

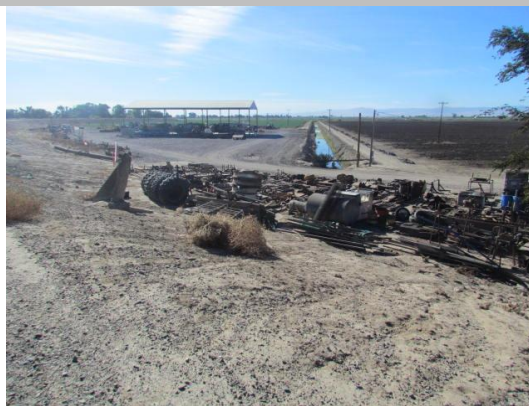
Photo 1 of 1 : SP_2017_RD0544_108_68_20170316_00049.jpg

Looking west at equipment at landward toe.

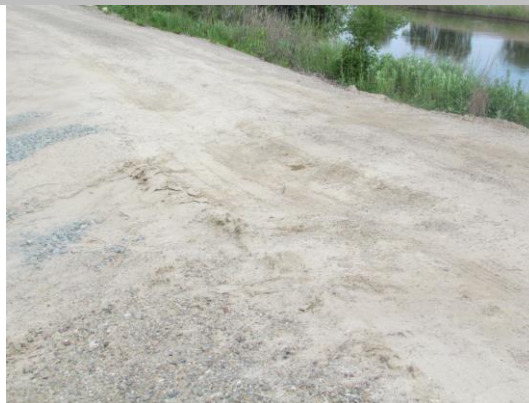
Photo 1 of 1 : SP_2017_RD0544_108_91_20170410_00135.jpg

Looking south at depression on levee crown and landward slope.

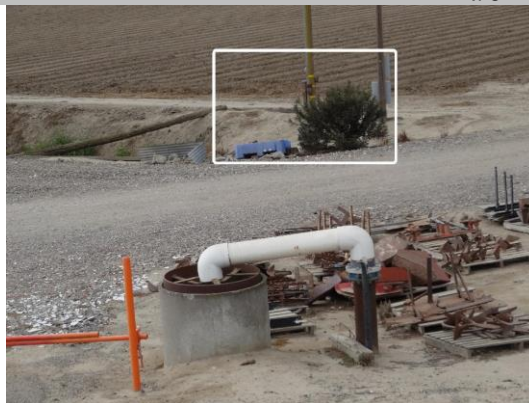
Photo 3 of 3 : UCIP_SP_2017_46671_44834.jpg

LS view: pump on drainage ditch bank about 140 ft from the levee.

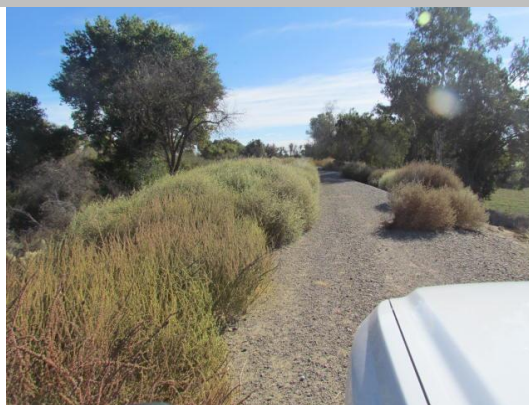
Photo 1 of 1 : SP_2017_RD0544_108_99_20170316_00064.jpg

Looking south at dense vegetation on waterward shoulder and slope.

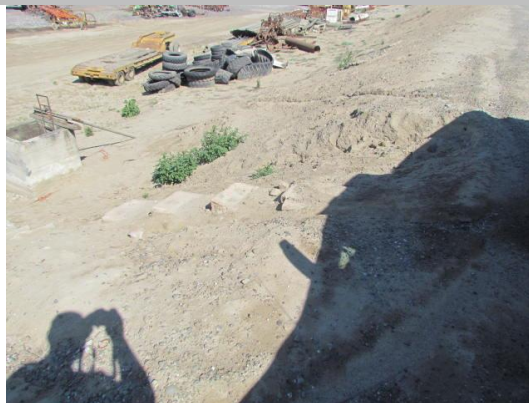
Photo 1 of 2 : SP_2017_RD0544_108_60_20170316_00043.jpg

Looking north at slope damage on landside slope.

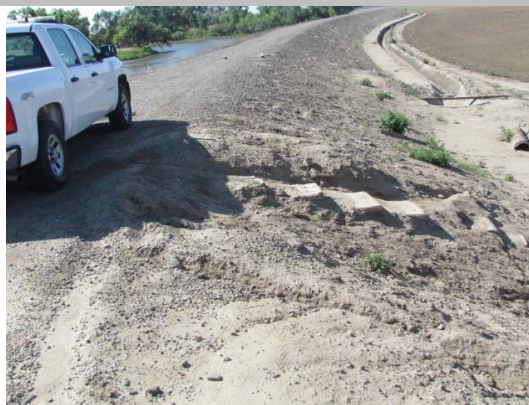
Photo 2 of 2 : SP_2017_RD0544_108_60_20170316_00044.jpg

Looking south at slope damage on landside slope.

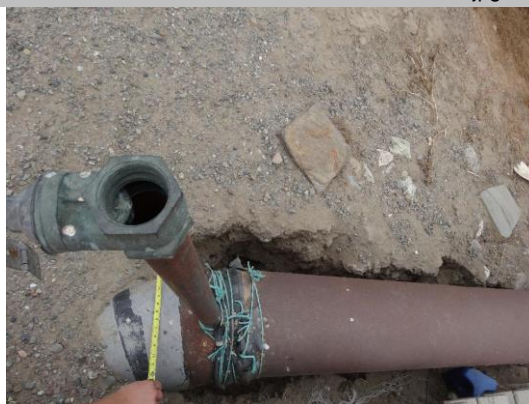
Photo 2 of 3 : UCIP_SP_2017_51361_44838.jpg

WS view: exposed pipe, air relief valve, and huge erosion on levee slope.

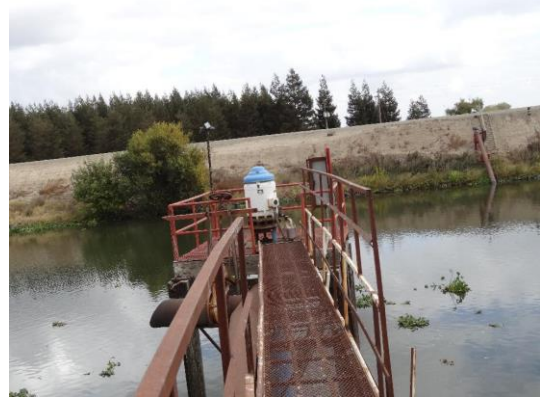
Photo 3 of 3 : UCIP_SP_2017_51361_44837.jpg

WS view: walkway to pump and pump on pile structure in the stream.

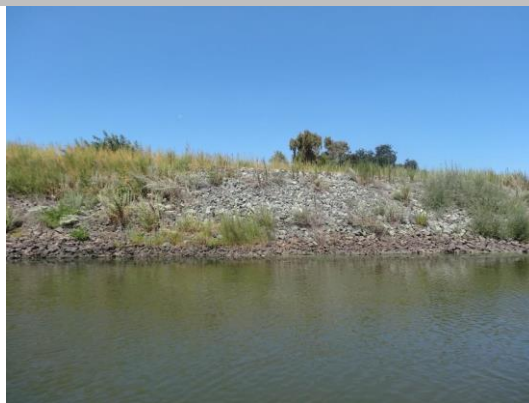
Photo 1 of 2 : SP_2017_RD0544_108_46_20170316_00035.jpg

Front view of the erosion.

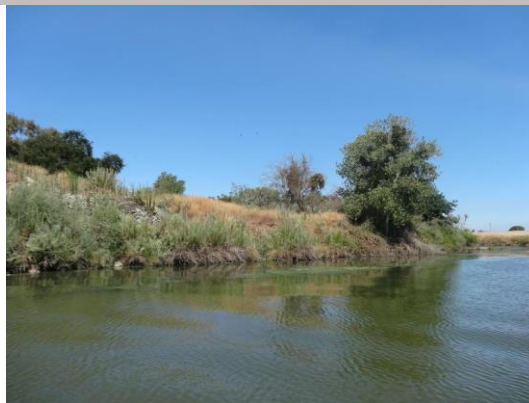
Photo 2 of 2 : SP_2017_RD0544_108_46_20170316_00036.jpg

Close view of the site.

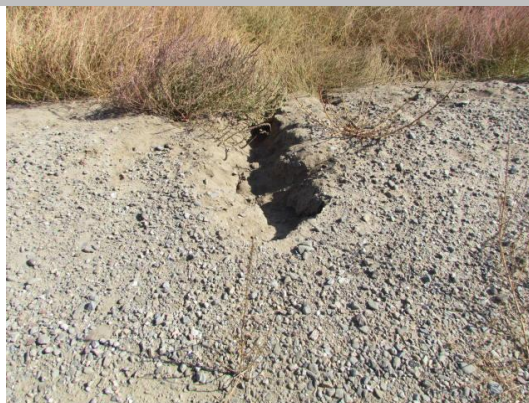
Photo 1 of 1 : SP_2017_RD0544_108_76_20170316_00050.jpg

Looking east at slope damage on waterward slope.

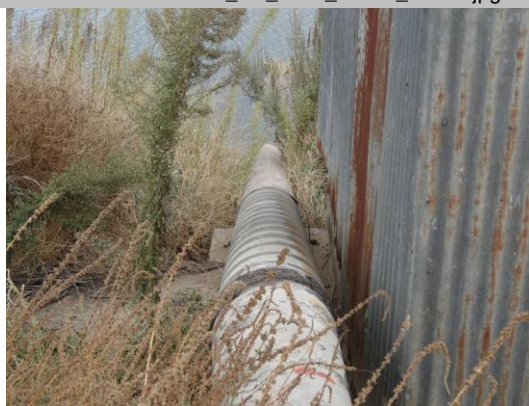
Photo 3 of 3 : UCIP_SP_2017_51365_42205.jpg

WS view: exposed steel pipe immersed into the stream. No pump attached.

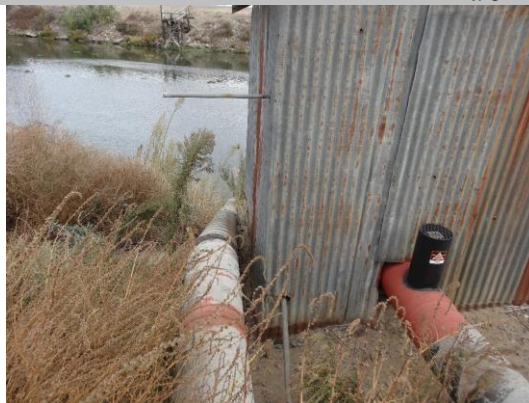
Photo 3 of 3 : UCIP_SP_2017_51366_44843.jpg

WS view: exposed steel pipe (right) with flow meter near pump house.

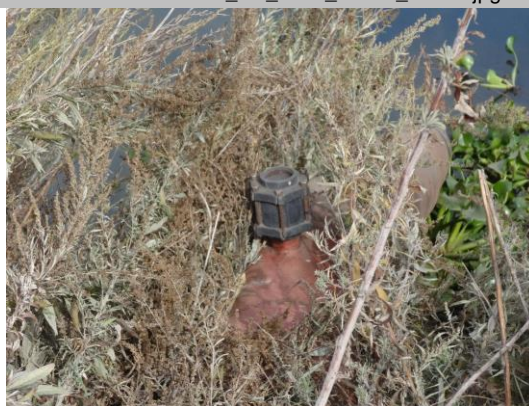
Photo 1 of 3 : UCIP_SP_2017_24892_44853.jpg

WS view: exposed steel pipe on bank of the channel.

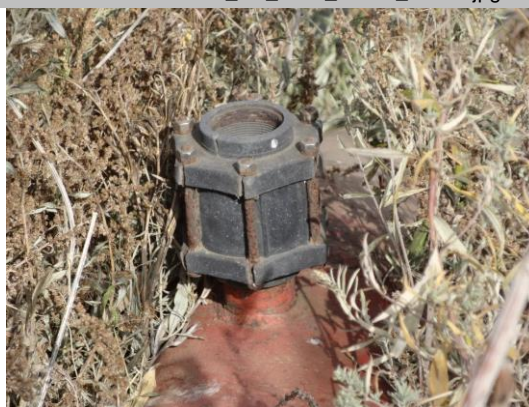
Photo 2 of 3 : UCIP_SP_2017_24892_44852.jpg

WS view: exposed steel pipe and air vent on the pipe.

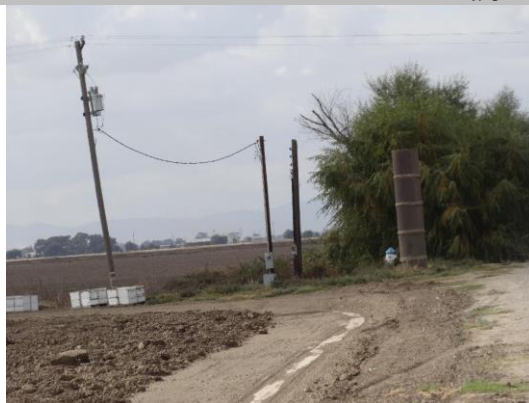
Photo 3 of 3 : UCIP_SP_2017_24892_44851.jpg

LS view: service pole, pump, and a concrete standpipe on bank of drainage ditch about 500 ft from the levee.

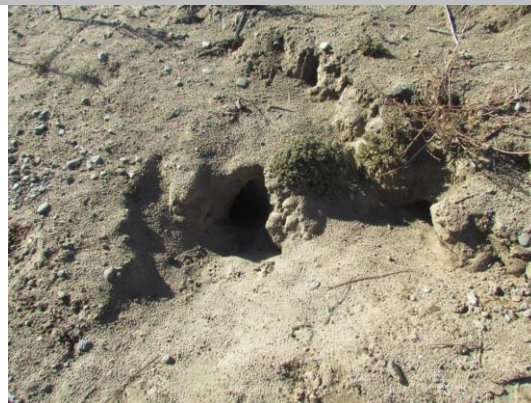
Photo 1 of 1 : SP_2017_RD0544_108_11_20170316_00013.jpg

Looking at large rodent holes on waterward slope.

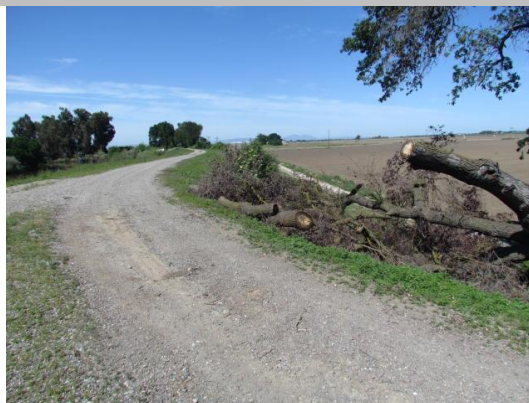
Photo 1 of 2 : SP_2017_RD0544_108_123_20170316_00085.jpg

Looking southwest at tree limbs on landward slope,

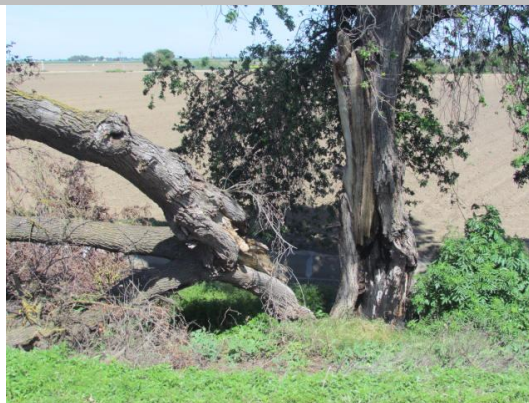
Photo 2 of 2 : SP_2017_RD0544_108_123_20170316_00086.jpg

Looking west at split tree on landward slope.

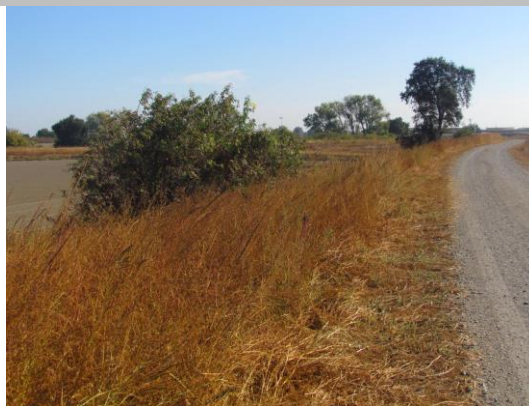
Photo 1 of 1 : SP_2017_RD0544_108_52_20170316_00041.jpg

Looking south at dense veg on landward slope.

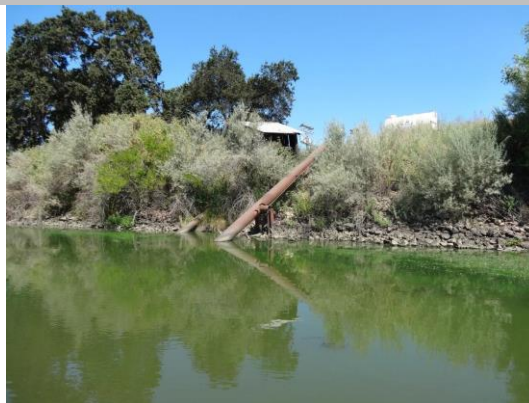
Photo 1 of 2 : SP_2017_RD0544_108_84_20170316_00052.jpg

Front view of the site.

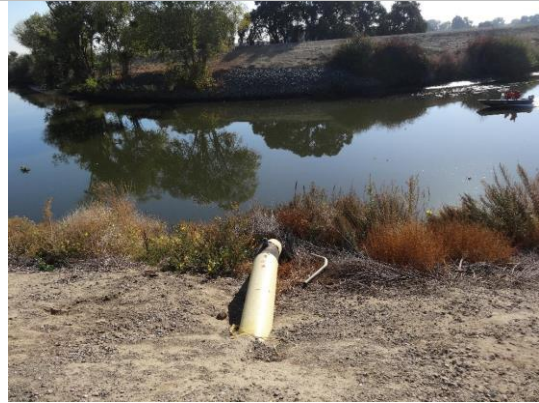
Photo 1 of 3 : UCIP_SP_2017_51379_44864.jpg

WS view: exposed steel pipe on levee slope.

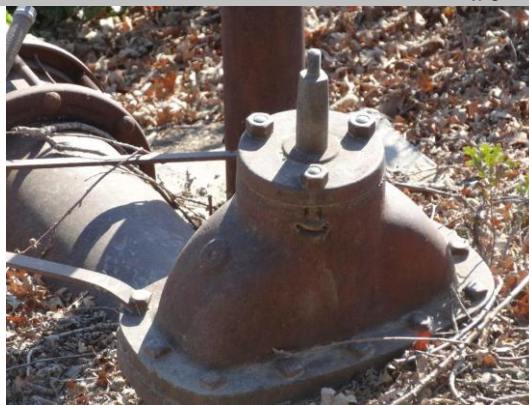
Photo 2 of 3 : UCIP_SP_2017_42962_42876.jpg

WS view: gate valve without handwheel on levee slope.

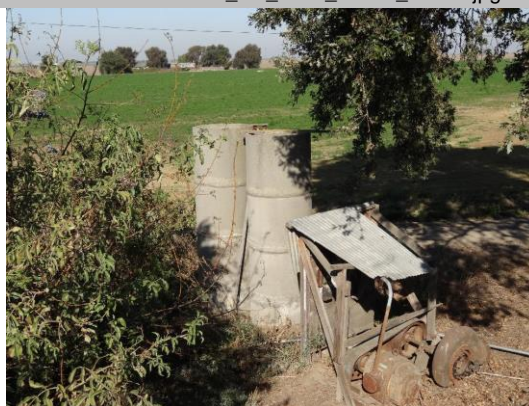
Photo 3 of 3 : UCIP_SP_2017_42962_42875.jpg

LS view: two concrete standpipes and abandoned pump on levee slope.

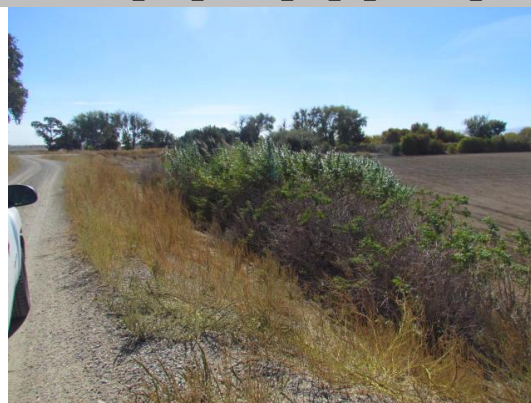
Photo 1 of 1 : SP_2017_RD0544_108_35_20170316_00028.jpg

Looking south at bamboo on landward slope and toe.

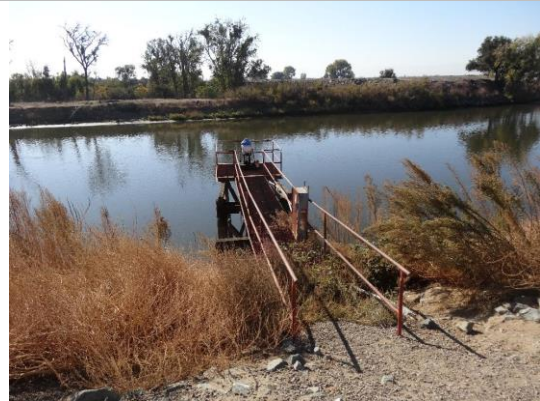
Photo 1 of 3 : UCIP_SP_2017_51384_42872.jpg

WS view: pump on pile structure, walkway to the pump on levee slope.

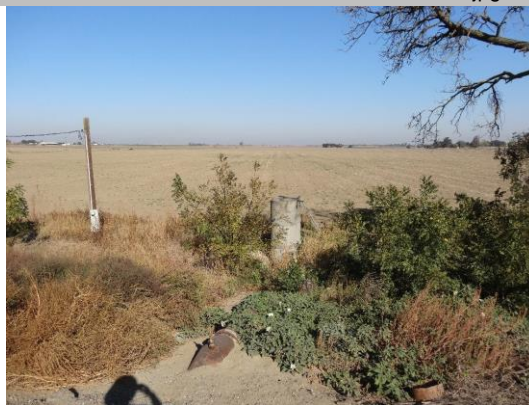
Photo 3 of 3 : UCIP_SP_2017_51384_42870.jpg

LS view: exposed pipe and pressure valve on levee slope. Two concrete standpipes on levee toe.

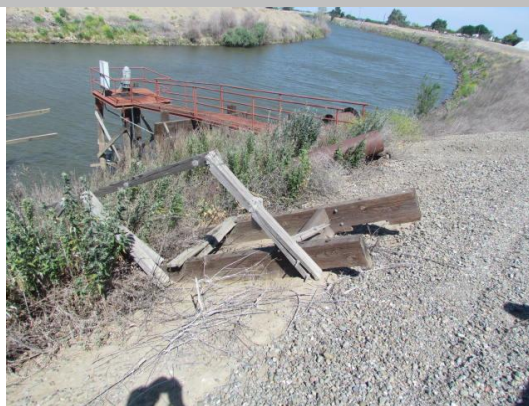
Photo 1 of 1 : SP_2017_RD0544_109_6_20170316_00004.jpg

Looking southeast at garbage on waterside shoulder and slope.

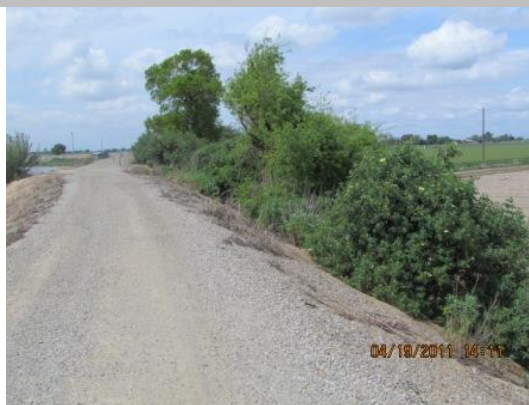
Photo 1 of 2 : SP_2017_RD0544_109_10_20170316_00015.jpg

Looking southwest at elderberries on landside slope.

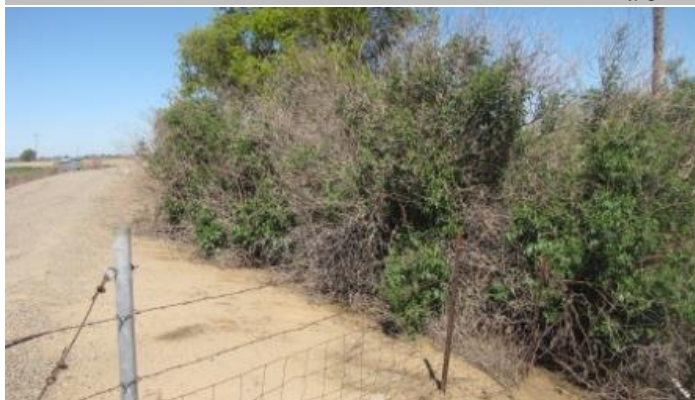
Photo 2 of 2 : SP_2017_RD0544_109_10_20170316_00016.jpg

Looking south at elderberries on landside slope and toe.

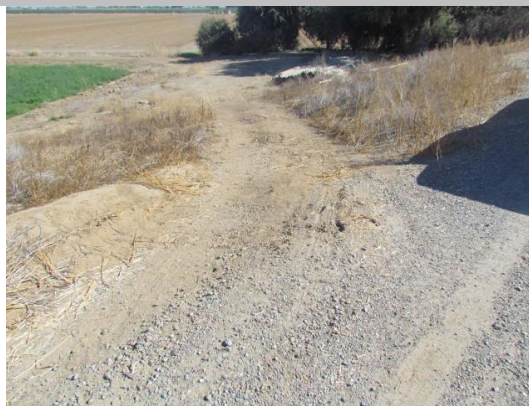
Photo 1 of 2 : SP_2017_RD0544_109_22_20170316_00028.jpg

Looking northwest at slope damage caused by vehicle traffic (Fall 2014).

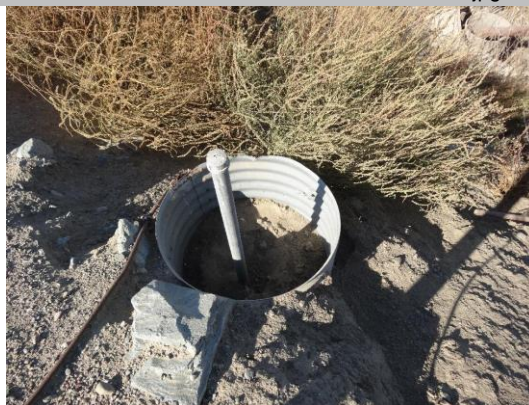
Photo 3 of 3 : UCIP_SP_2017_24907_44893.jpg

WS view: air vent on CMP riser on levee shoulder.

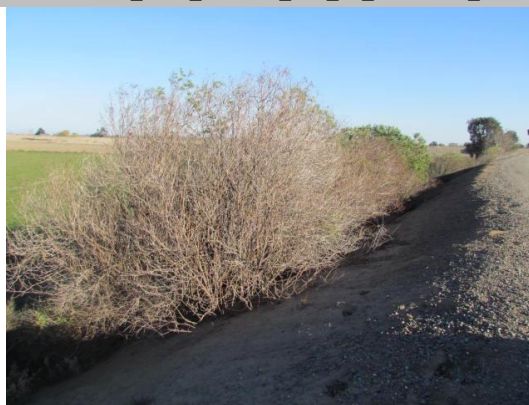
Photo 1 of 1 : SP_2017_RD0544_109_13_20170316_00019.jpg

Looking northwest at elderberries on landside slope and toe.

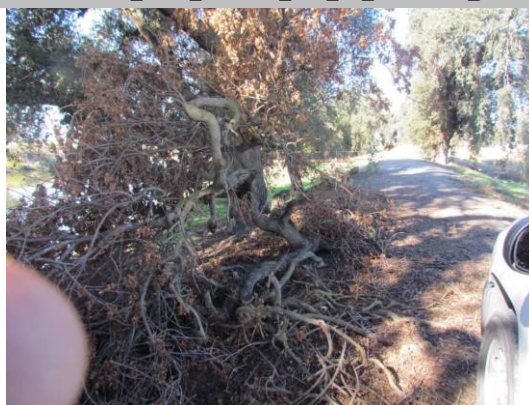
Photo 1 of 1 : SP_2017_RD0544_109_68_20170316_00054.jpg

Looking at broken tree branch on waterward shoulder.

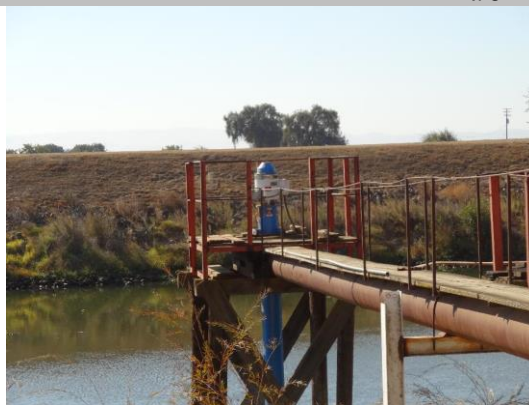
Photo 2 of 3 : UCIP_SP_2017_41731_42953.jpg

WS view: closer view of pipe, walkway, and pump on pile structure.

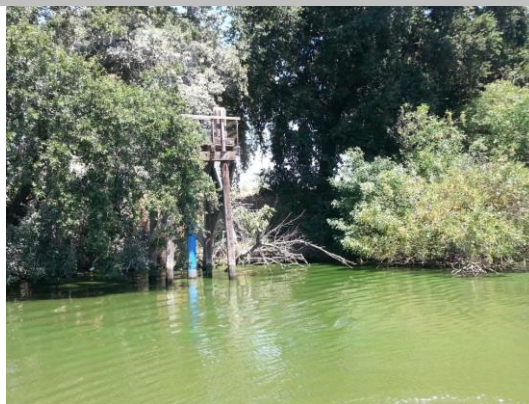
Photo 2 of 2 : SP_2017_RD0544_109_12_20170316_00018.jpg

Close view of the site.

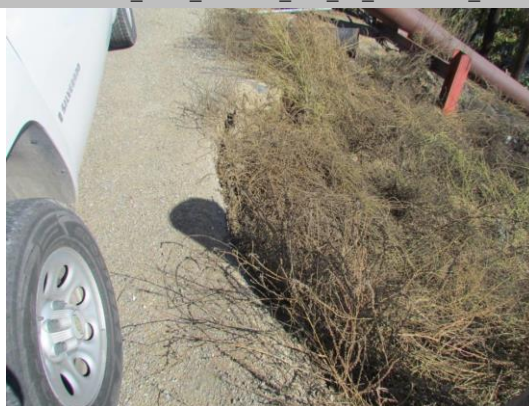
Photo 2 of 3 : SP_2017_RD0544_109_69_20170316_00056.jpg

Looking north at erosion on waterward shoulder and slope.

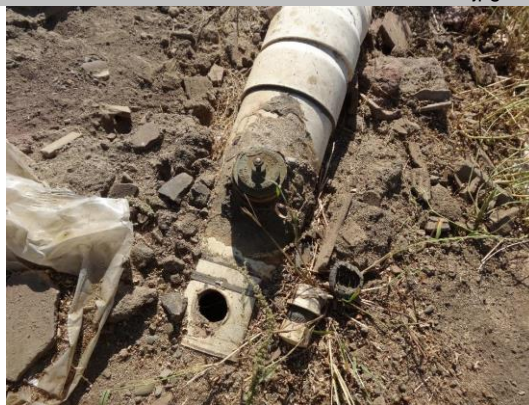
Photo 2 of 3 : UCIP_SP_2017_24908_44897.jpg

WS view: 8" white pvc pipe with siphon breaker on levee shoulder. An unplugged hole on the pipe.

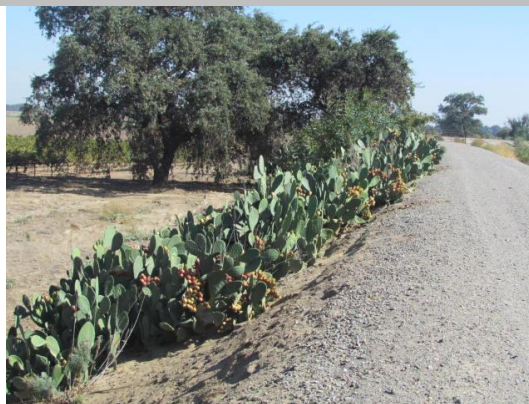
Photo 1 of 3 : SP_2017_RD0544_109_36_20170316_00031.jpg

Looking northwest at cactus on landward slope and toe fall 2015

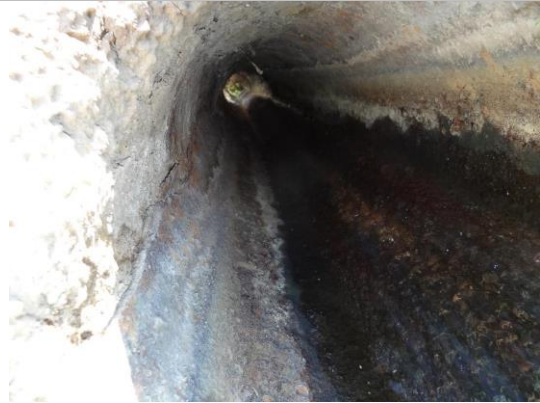
Photo 3 of 3 : UCIP_SP_2017_51375_43003.jpg

WS view: inside view of hole in deteriorated pipe.
